Trane CVHF 1500 ton Centrifugal Chiller Compressor Lift Case Study

Municipal Chiller plant serving a major hospital

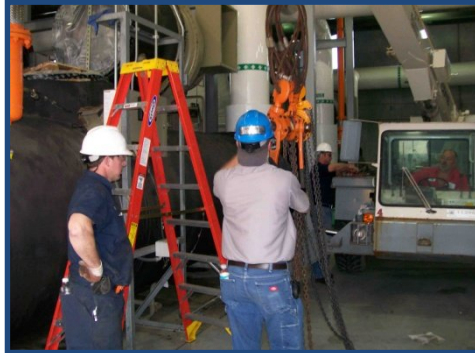
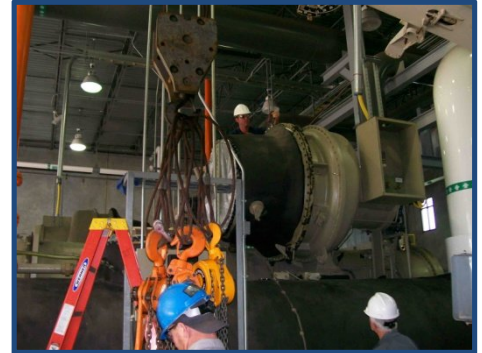
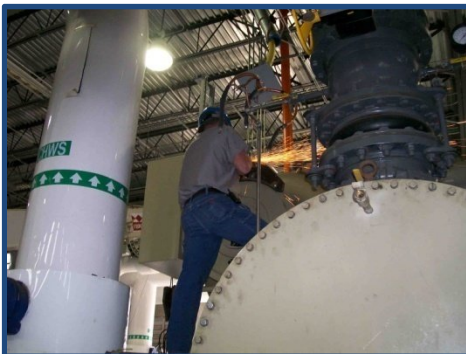
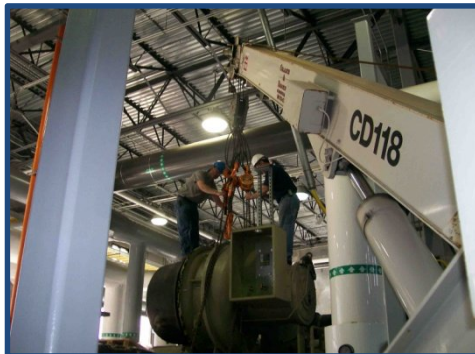
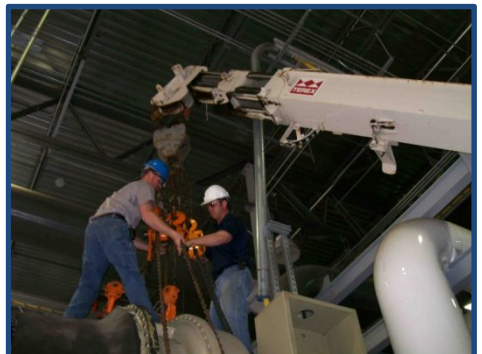
Leaking discharge O ring needed replacement

14,000lbs compressor lift

Used a crane with inches to spare in overhead space

Normal procedure would be to breakdown the compressor to get to the O ring, however, this procedure represented half the normal repair time at half the cost.
